DEPARTMENT OF TRANSPORTATION**DIVISION OF ENGINEERING SERVICES**

Contract #: 04-0120F4Cty: SF/ALA Rte: 80 PM: 13.2/13.9File #: 69.28**WELDING INSPECTION REPORT****Resident Engineer:** Pursell, Gary**Address:** 333 Burma Road**City:** Oakland, CA 94607**Report No:** WIR-004212**Date Inspected:** 22-Sep-2008**Project Name:** SAS Superstructure**OSM Arrival Time:** 700**Prime Contractor:** American Bridge/Fluor Enterprises, a JV**OSM Departure Time:** 1530**Contractor:** Zhenhua Port Machinery Company, Ltd (ZPMC), Changxing Island **Location:** Shanghai, China**CWI Name:** See below**CWI Present:** Yes No**Inspected CWI report:** Yes No N/A**Rod Oven in Use:** Yes No N/A**Electrode to specification:** Yes No N/A**Weld Procedures Followed:** Yes No N/A**Qualified Welders:** Yes No N/A**Verified Joint Fit-up:** Yes No N/A**Approved Drawings:** Yes No N/A**Approved WPS:** Yes No N/A**Delayed / Cancelled:** Yes No N/A**Bridge No:** 34-0006**Component:** Tower & OBG**Summary of Items Observed:**

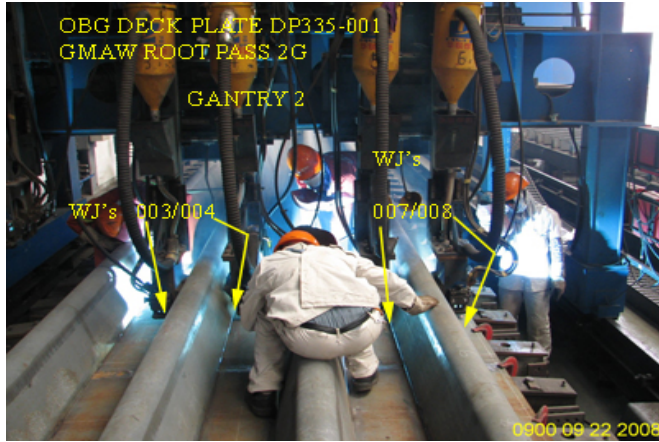
The QA Inspector randomly observed ZPMC welders Jiang Shuang Chen ID 201788/Song Yin Shu ID 059421 (WJ's 003/004) and Wang Xiao Rong ID 059445/Zhang Shanhui ID 059403 (WJ's 005/006), utilizing the Gas Metal Arc Welding (GMAW) Process in the 2G (Flat Groove) Position with ZPMC WPS WPS-B-T-2342-U1(U-Rib)-4, to weld the root pass in WJ's 003/004 and 005/006 attaching U-Ribs U-214 and U-216 to Deck Plate DP335-001. The QA Inspector randomly observed ZPMC QC under the supervision of ZPMC CWI Sun Wei, monitoring weld parameters. The QA Inspector also randomly observed weld parameters and recorded them as follows: 378/365 amps, 30.9/31.2 volts for WJ's 003/004; 373/375 amps, 31.9/31.1 volts for WJ's 005/006 with a travel speed of 633 millimeters per minute for all the above listed WJ's. The weld parameters appeared to comply with contract requirements. The attached photograph provides additional detail.
